Memo

Project: Seismic Resilience Assessment

To: Brett Musick, PE, City of Newberg

Subject: Executive Summary

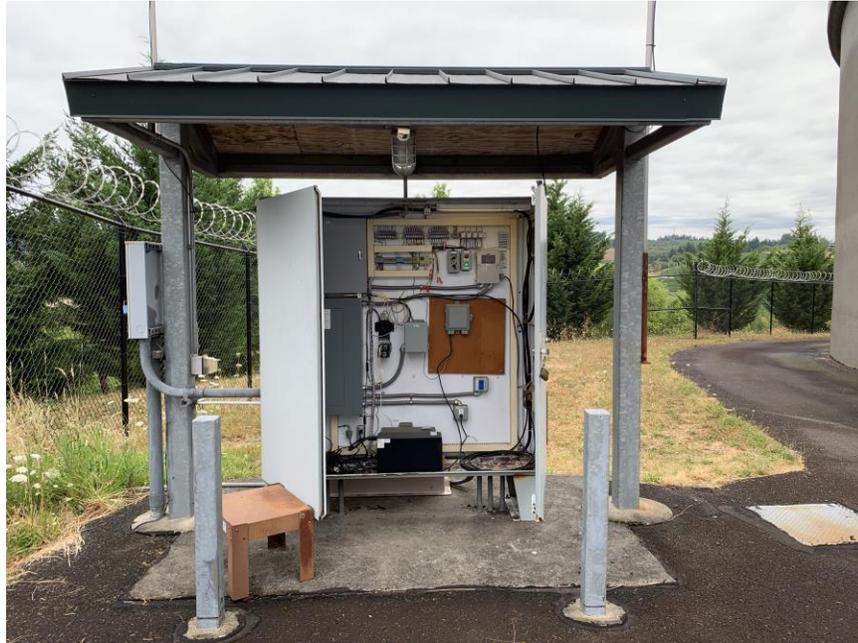
An electrical panelboard and SCADA equipment is located adjacent to the reservoir in a metal electrical enclosure. The enclosure is covered by a canopy that is supported by steel tube section cantilever posts, as shown in Figure 3.2.

Figure 3.2 – Electrical Panelboard and SCADA Equipment Enclosure and Canopy

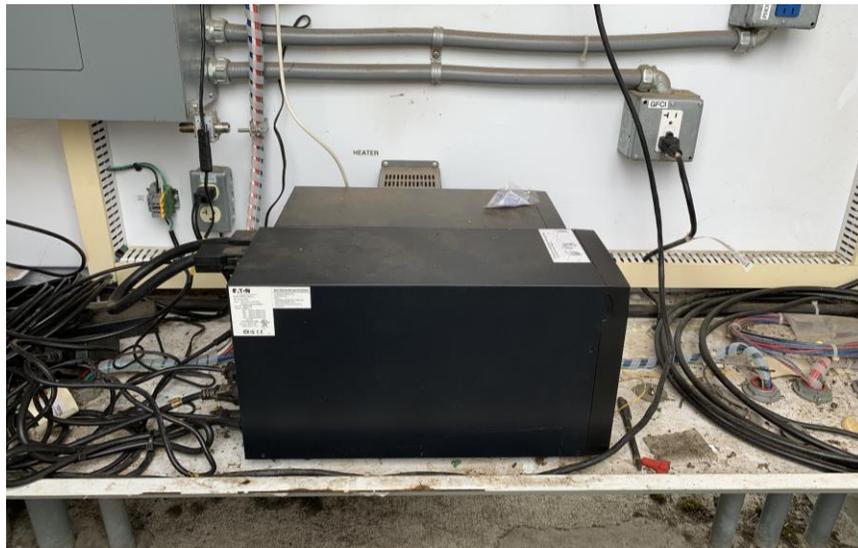
Potential Deficiencies	Description
Structural	<ul style="list-style-type: none"> • Per Shannon & Wilson Report, minimal permanent ground deformation (PGD) is anticipated at the reservoir: 0 inches liquefaction induced settlement, 0-0.1 inches liquefaction-induced lateral spreading, and approximately 0.5 feet earthquake-induced landslide PGD near slope 100 feet from reservoir. This level of PGD is not anticipated to cause significant structural damage to the reservoir. However, the impact of earthquake-induced landslide PGD should be considered as a potential hazard for the buried pipelines that connect to the reservoir and are located in the potential landslide zone. • None Identified.
Nonstructural	<ul style="list-style-type: none"> • SCADA system backup batteries inside metal enclosure are not restrained. See Figure 3.3.

Figure 3.3 – Unrestrained Backup Batteries

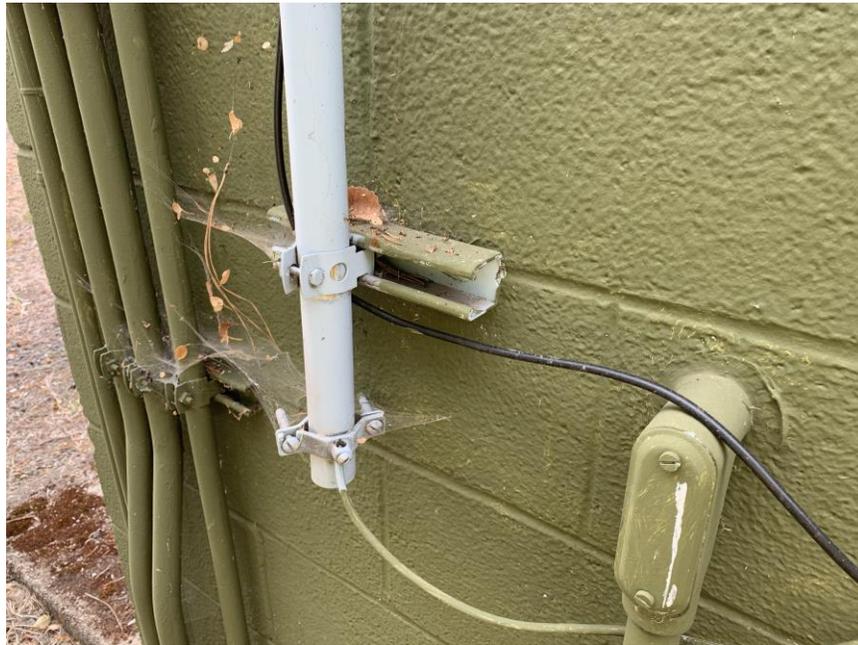
Figure 3.10– SCADA Antenna Supported with Friction Clips

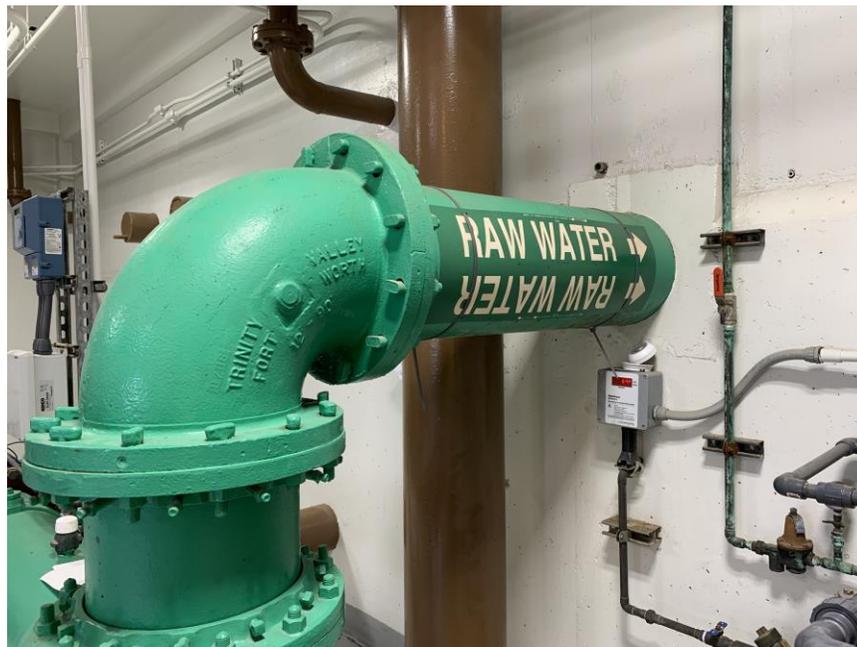
Potential Deficiencies	Description
<p>Nonstructural</p>	<ul style="list-style-type: none"> • Pipes that penetrate concrete walls do not have adequate flexibility through the wall to accommodate the relative movement between the wall and the pipes. See Figure 3.17. • The raw water piping and valves are not adequately seismically braced. See Figure 3.18. • Vertical pipes are not adequately braced to the structure to resist seismic forces and do not have adequate flexibility to accommodate inter-story drift. See Figure 3.19. • Large chemical storage containers/drums are not restrained. See Figure 3.20. • Rolling carts are not restrained. See Figure 3.21. • A cabinet is improperly anchored to an electrical conduit with a U-bolt. See Figure 3.22. • Storage racks are not restrained. See Figure 3.23. • Mechanical ducts are unbraced. See Figure 3.24. • In-line fan unit is not braced in the direction parallel to the wall. See Figure 3.25. • It is unknown if adequate dowels are provided between the electrical cabinet housekeeping pads and floor slab. • Large diameter electrical conduits are not braced and flexible connections are not provided between the conduit and the top of the electrical cabinets. See Figure 3.26. • At least one of the electrical cabinets appears to be missing anchors at the base of the cabinet. See Figure 3.27. • Vertical cast iron roof drain in Electrical Room is not braced to structure and does not have adequate flexibility to accommodate inter-story drift. Potential failure could cause water intrusion and consequent damage to electrical equipment. See Figure 3.28. • Lights on pendant supports are not braced and may potentially swing and cause damage to other components. Some light fixtures do not include lens covers to prevent the light tubes from falling. See Figure 3.29. • Refrigerator and filing cabinets adjacent to walkway are not restrained. See Figure 3.30.

Figure 3.17 – Concrete Wall Penetration by Raw Water Pipe

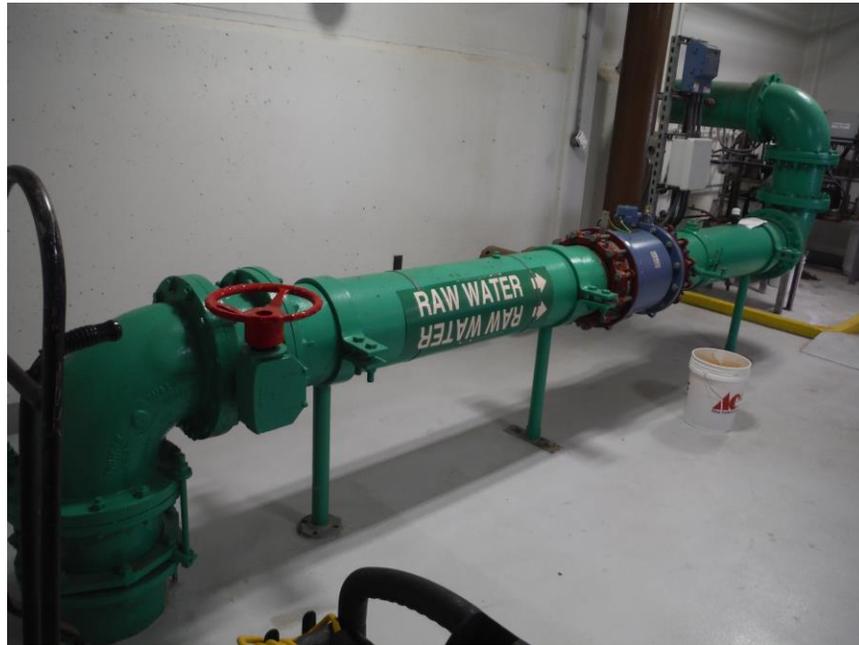
Figure 3.18 – Raw Water Piping System without Adequate Bracing

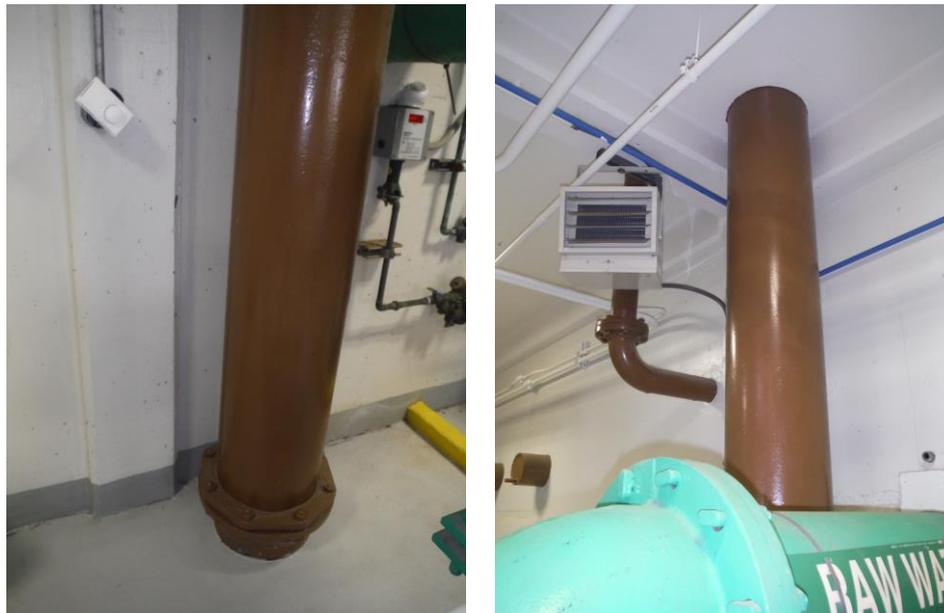
Figure 3.19 – Vertical Pipe without Lateral Restraint

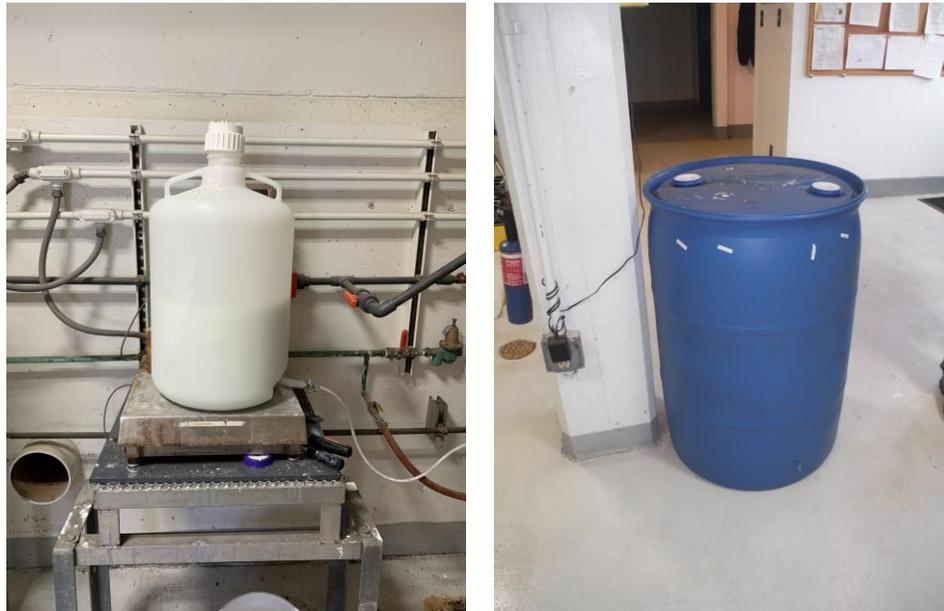
Figure 3.20 – Unrestrained Chemical Storage Containers

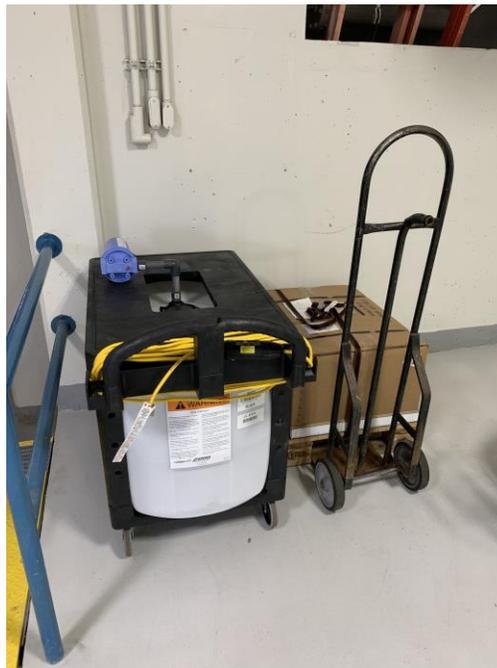
Figure 3.21 – Unrestrained Rolling Carts

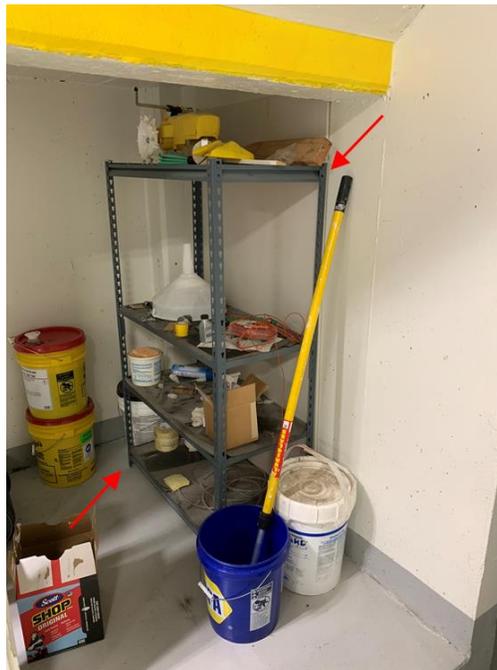
Figure 3.23 – Unrestrained Storage Rack

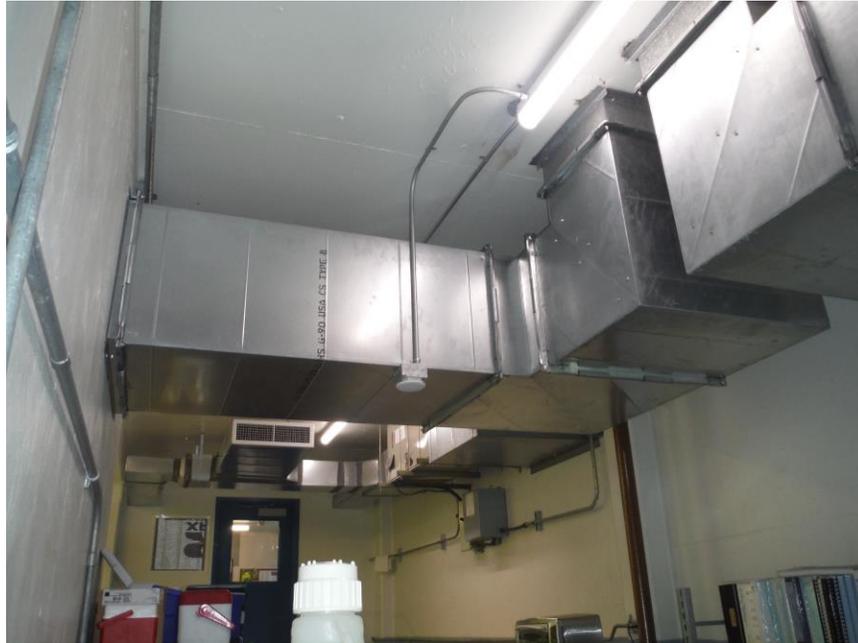
Figure 3.24 – Mechanical Ducts not Braced to Structure

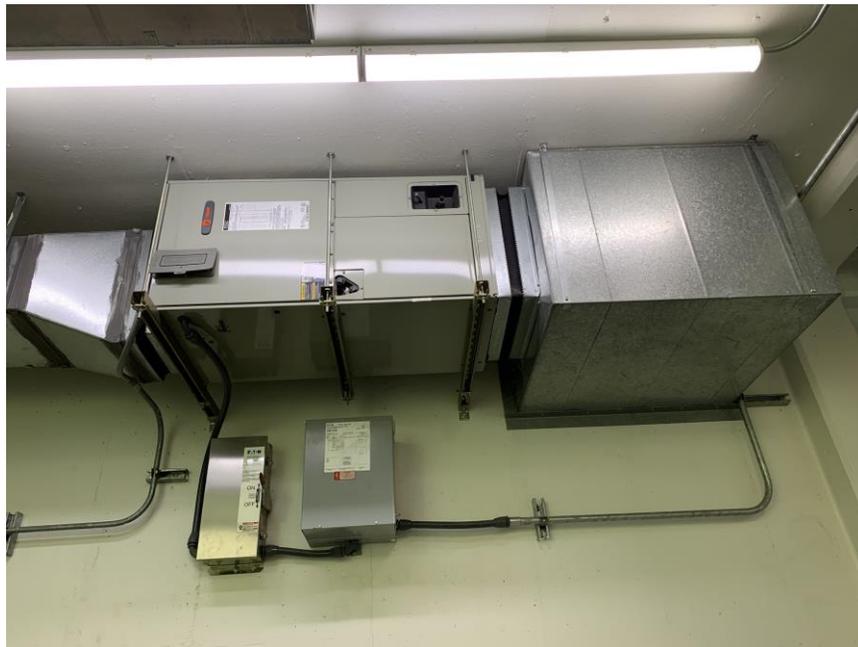
Figure 3.25 – In-Line Fan Unit Unrestrained to Movement Parallel to Wall

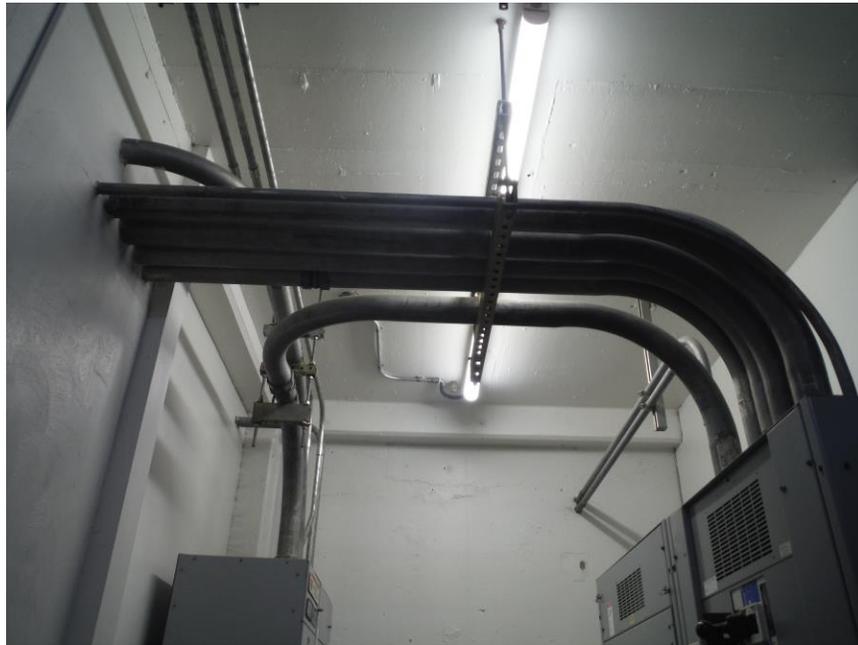
Figure 3.26 – Electrical Conduits not Seismically Braced and without Flexible Connections to Cabinets

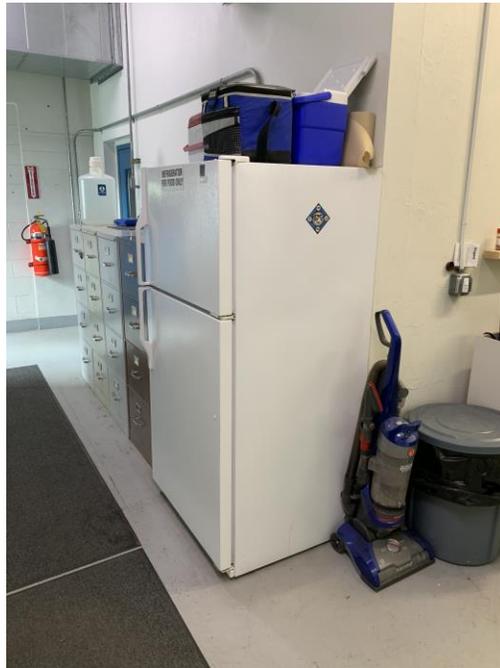
Figure 3.30 – Unrestrained Refrigerator and Filing Cabinets Adjacent to Walkway

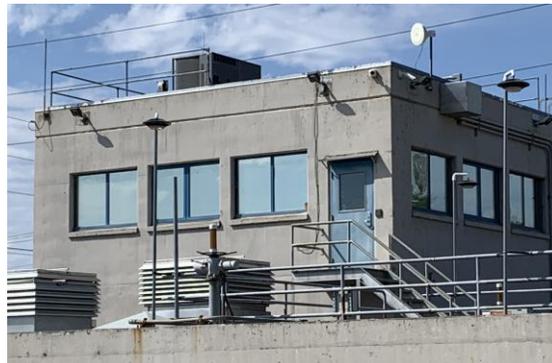
(a) Architectural Plan View of Control Room
 (Source Drawings: “Water Treatment Plant (A700004)”)

(b) Outside View of Control Room East and South Walls

Figure 3.37 – Reduction of Shear Walls Cross Section Due to Presence of Windows and Door

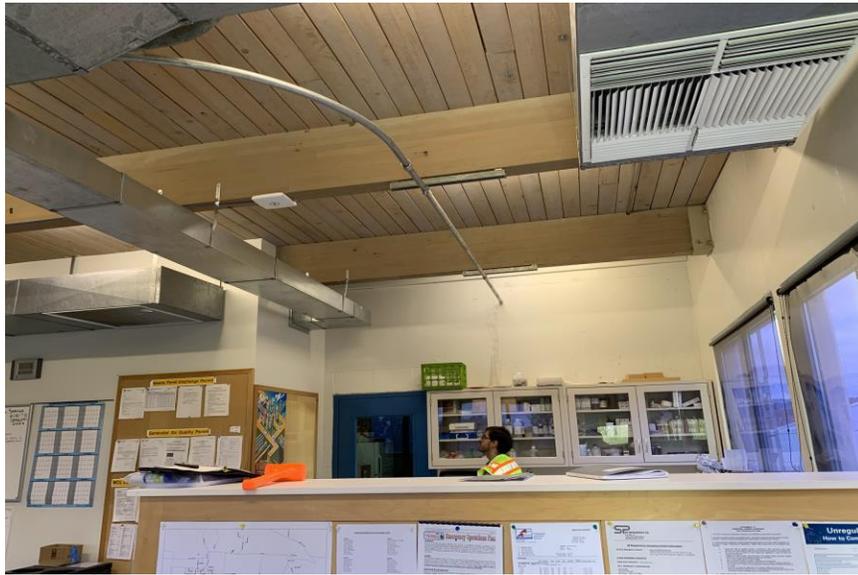
Figure 3.38 – Flexible Diaphragm Chords without Cross Ties

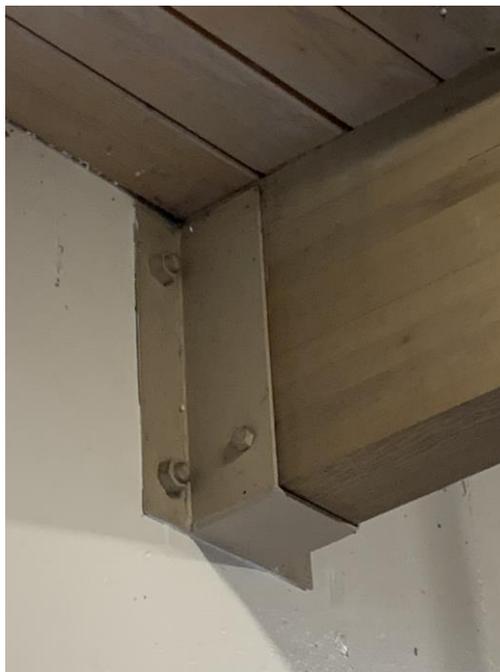
Figure 3.39 – Joist to Perpendicular Wall Connection

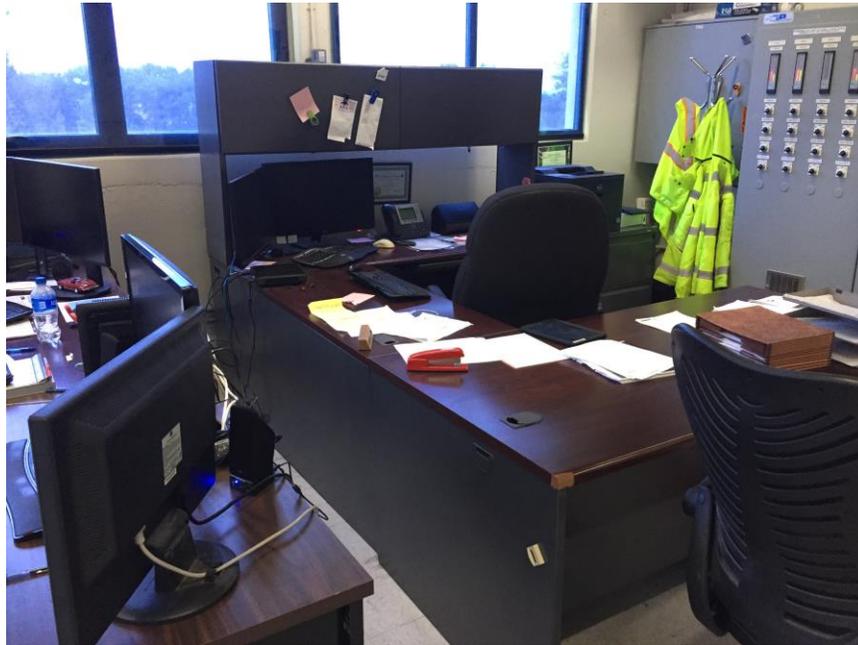
Figure 3.42 – Unrestrained Computer Equipment

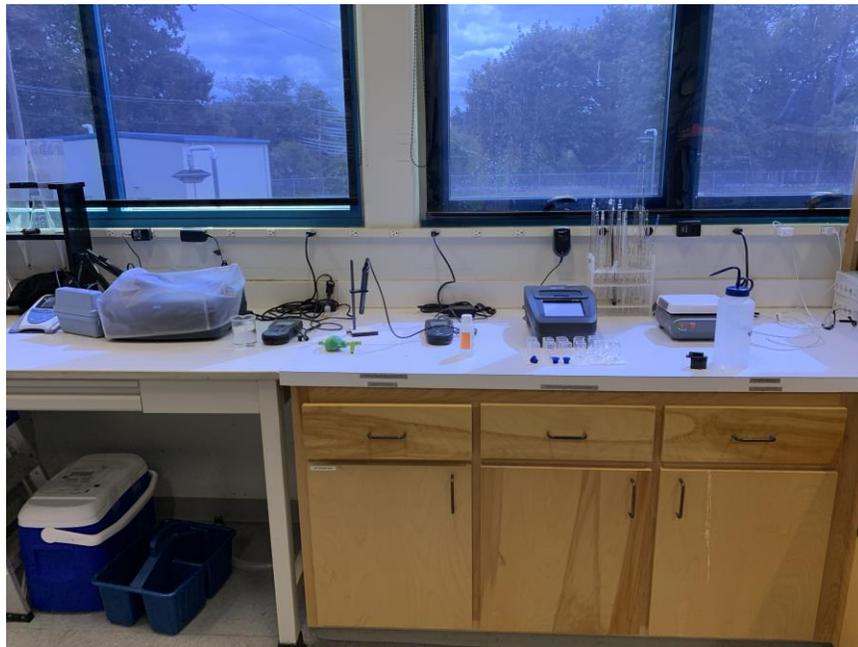
Figure 3.43 – Unrestrained Equipment on Lab Counter

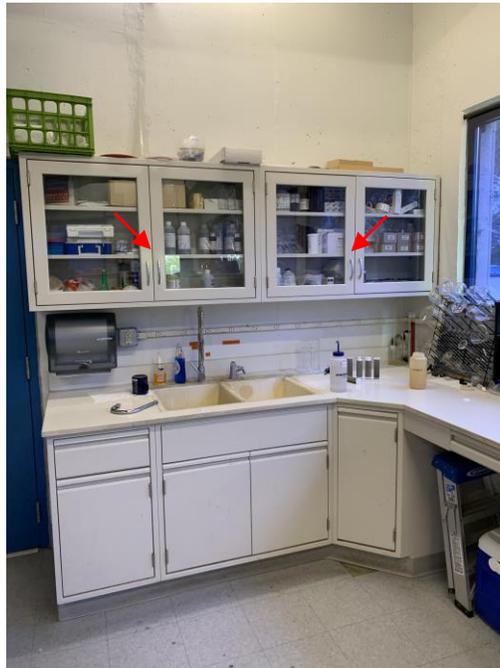
Figure 3.44 – Chemical Cabinet Doors without Proper Latches

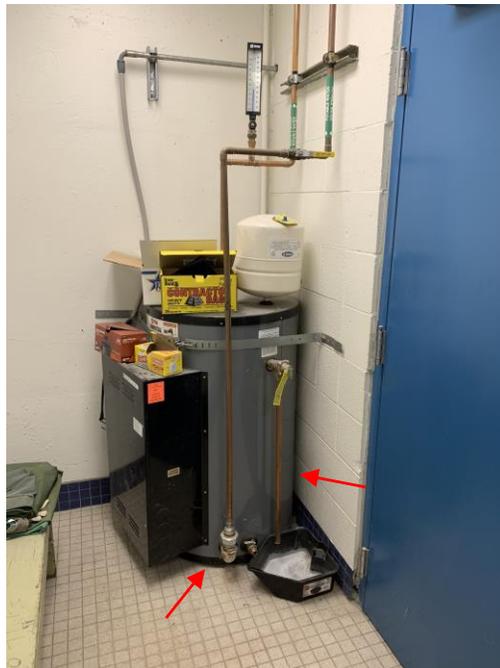
Figure 3.45 – Water Heater Tank not Adequately Restrained

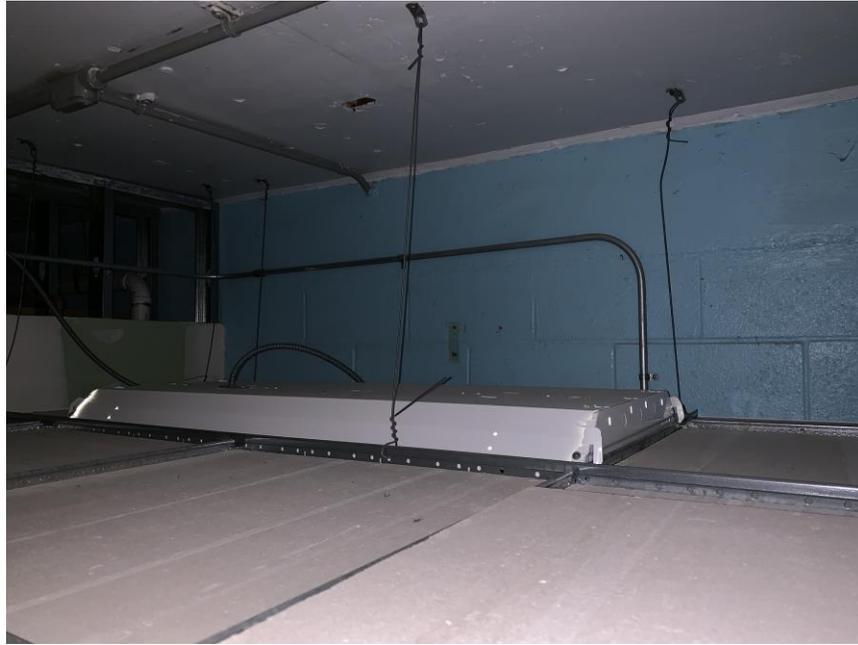
Nonstructural	<ul style="list-style-type: none"> • The CMU partition walls around the restrooms are constructed tight to the adjacent concrete beams and walls without an adequate separation to prevent them from unintentionally participating in resisting seismic loads. See Figure 3.41. • Computer equipment is unrestrained. See Figure 3.42. • Several pieces of equipment on the lab counter are unrestrained. See Figure 3.43. • Chemical cabinets doors are not properly latched to prevent accidental opening during an earthquake. See Figure 3.44. • Water heater is not adequately restrained. See Figure 3.45. • Light fixtures are supported by the ceiling grid and lack proper independent support. See Figure 3.46. • The suspended ceiling system is not adequately braced to the structure. See Figure 3.46.

Figure 3.46 – Light Fixture Supported by Ceiling Grid

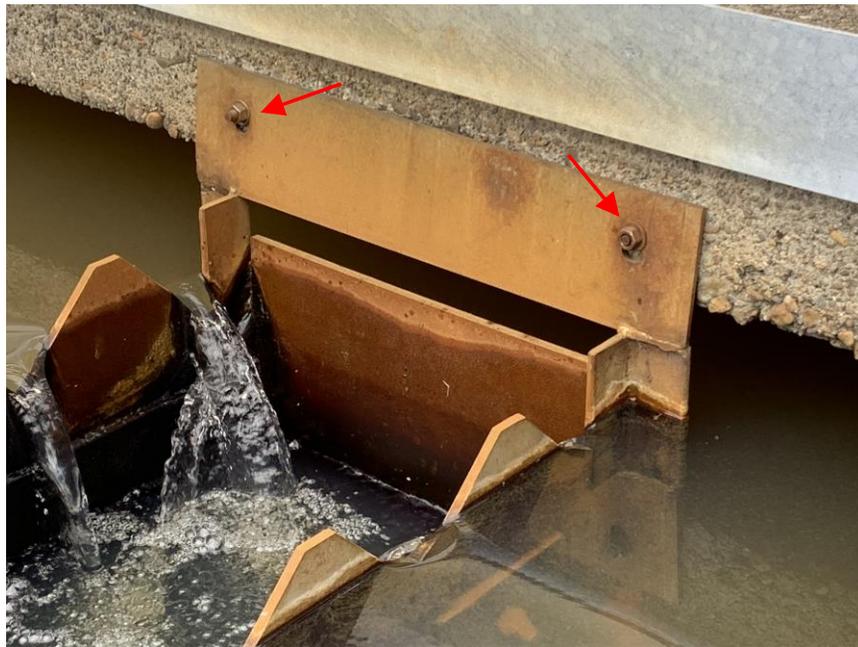
Nonstructural	<ul style="list-style-type: none"> • Wooden baffles may not have adequate strength to resist hydrodynamic forces. See Figure 3.51. • Small diameter anchors used to connect the weir troughs to the basin walls may not be adequate to resist hydrodynamic forces. See Figure 3.52. • Pipes that penetrate concrete walls may not have adequate flexibility to accommodate the relative movement between the wall and the pipes. See Figure 3.53.

Figure 3.52 – Weir Trough to Basin Structure Connection Using Small Diameter Anchors

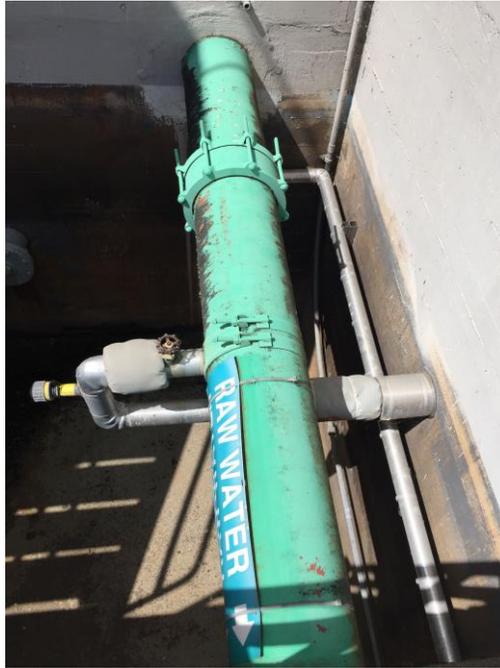
Figure 3.53 – Raw Water Pipes Penetrating Concrete Wall without Adequate Flexibility Through Wall

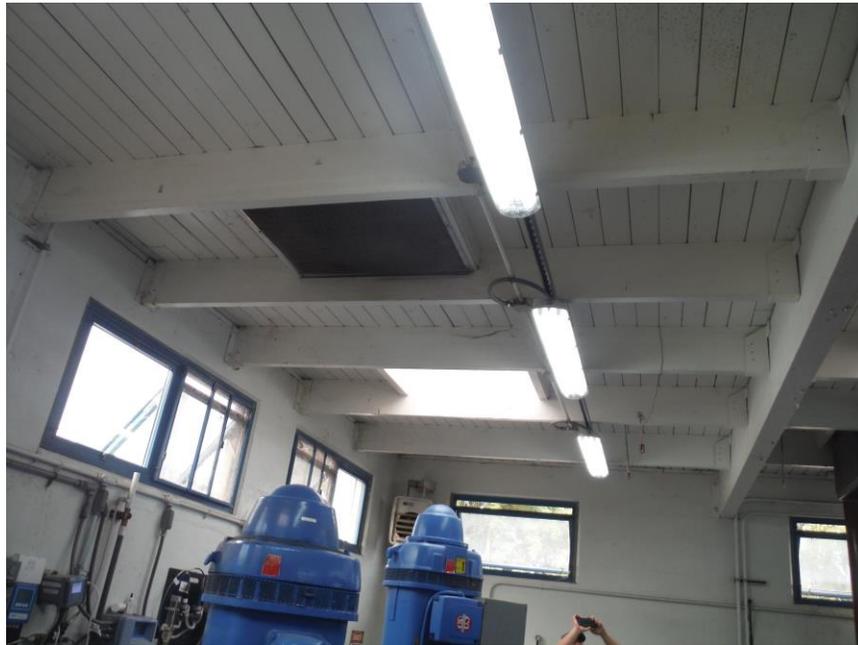
Figure 3.59 – Flexible Diaphragm without Cross Ties

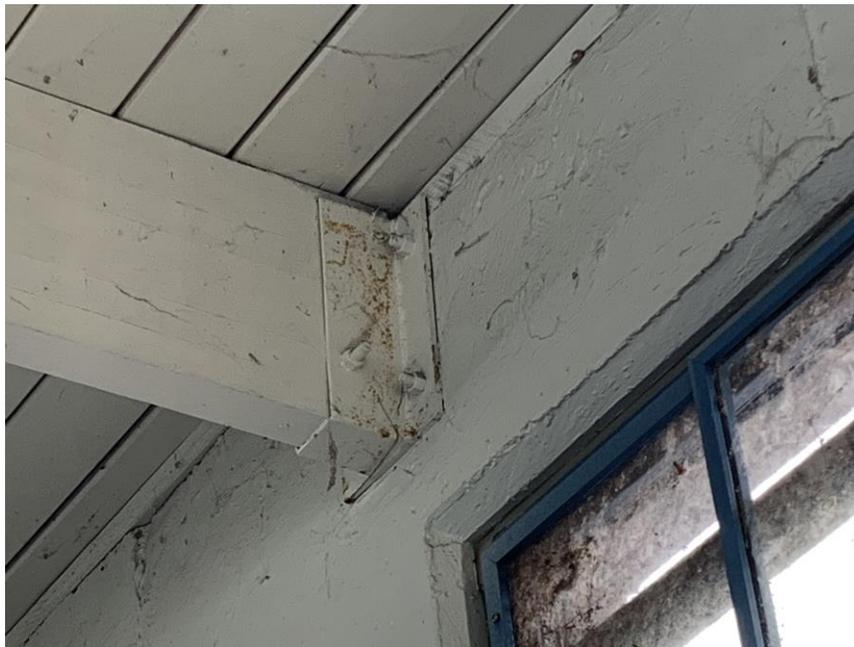
Figure 3.60 – Joist to Perpendicular Wall Connection

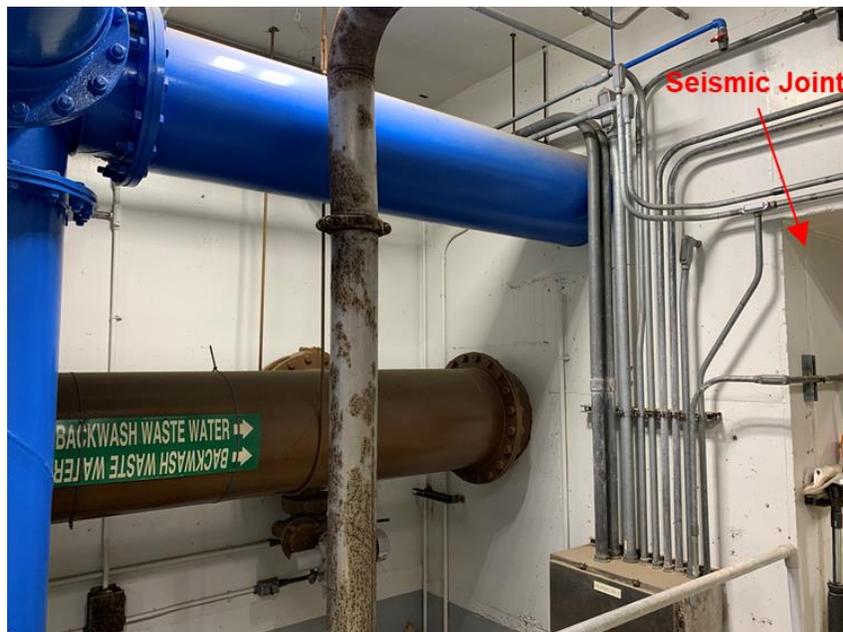
Figure 3.62 – Finished Water Sample Pipe and Filter Backwash Pipe Cross Seismic Joint without Adequate Flexibility

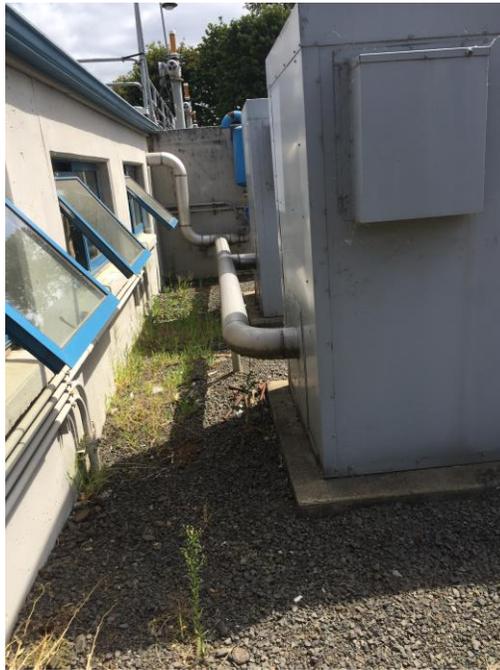
Figure 3.65 – Air Scour Piping from Blowers to Filter Gallery without Adequate Flexibility to Accommodate Differential Movement

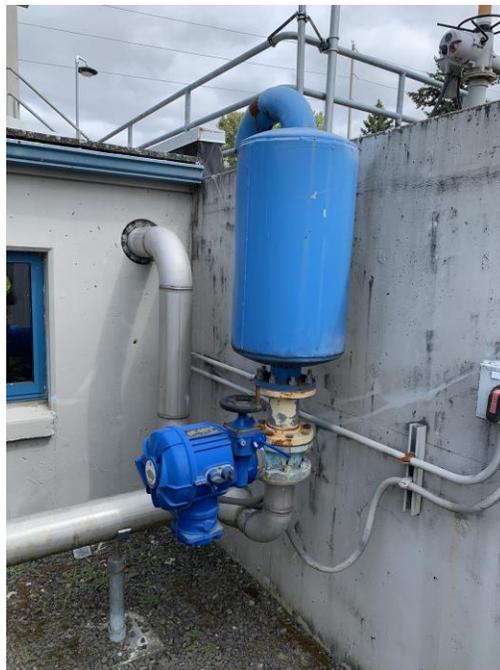
Figure 3.66 – Air Vent Valve and Muffler not Adequately Braced

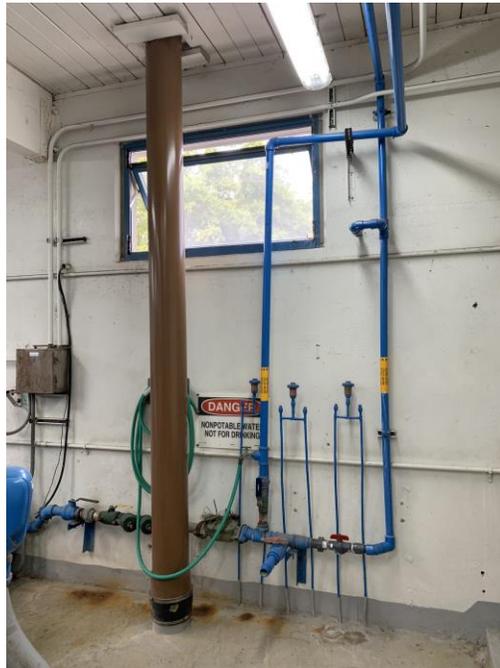
Figure 3.67 – Air Relief Piping Penetrating Laterally Unrestrained

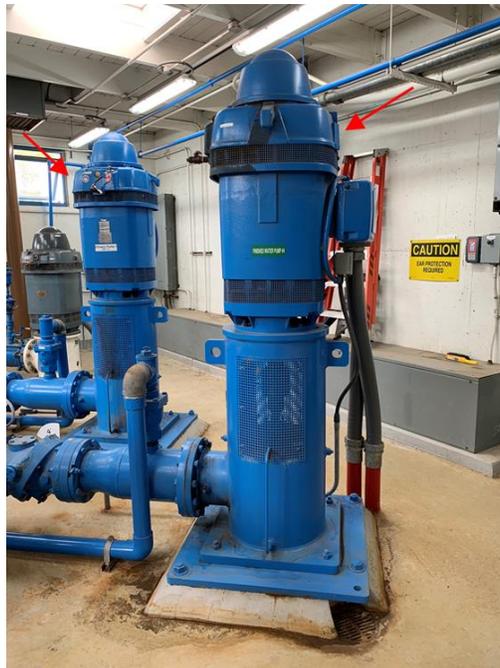
Figure 3.68 – Pump Motors not Braced to Structure Above their Center of Gravity

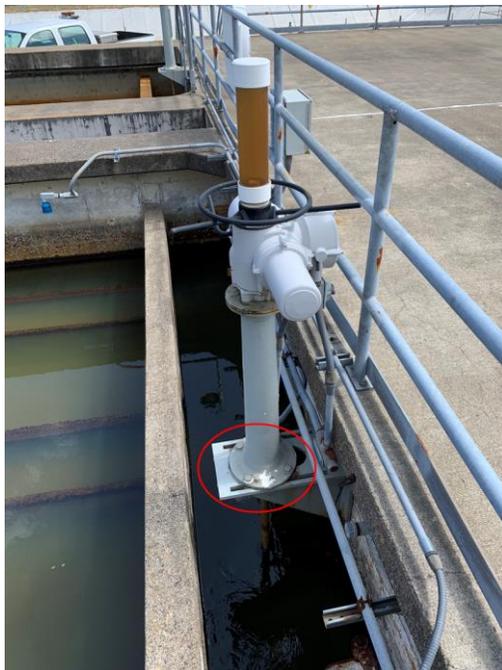
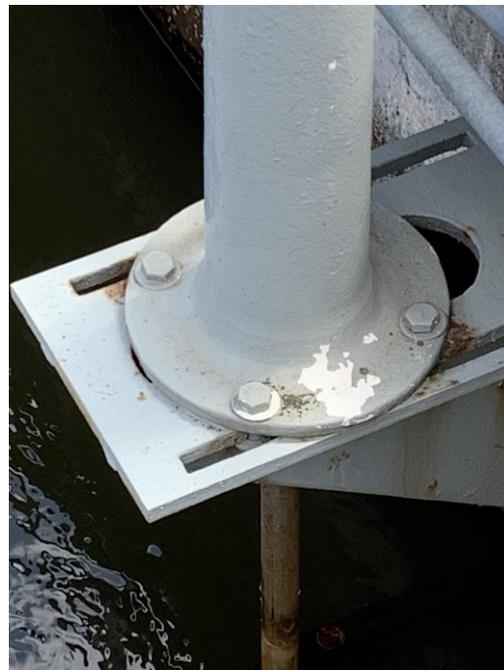
Potential Deficiencies	Description
Nonstructural (cont.)	<u>Filters</u> <ul style="list-style-type: none">• Valve operators are not adequately anchored to the Filter structure to resist seismic forces. They are bolted to slotted base plates that appear to have been significantly modified. See Figure 3.70.

Figure 3.70 – Valve Actuators Installed on Significantly Modified Base Plates

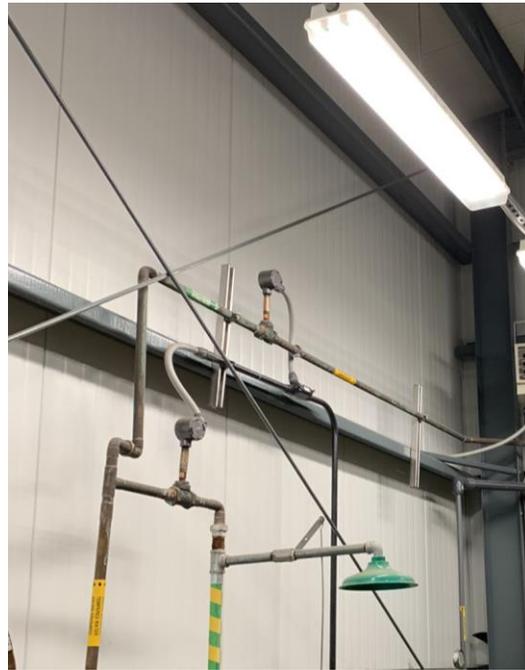
Figure 3.73 – Single Lateral Force Resisting Bay in Frame Line along East-West Direction

Potential Deficiencies	Description
<p>Structural</p>	<ul style="list-style-type: none"> • Permanent ground deformation – see first bullet of Table 3.4. • The lateral force resisting system lacks redundancy in both directions since there is only one lateral force resisting bay per frame line. See Figures 3.73 and 3.74. • The load path to transfer seismic forces from the roof diaphragm to the moment frame beam is not adequate since there is no blocking provided between purlins. See Figure 3.75. • The load path to transfer seismic forces from the roof diaphragm to the braced frame tension rod bracing involves indirect force transfer from the roof diaphragm to the purlins and then out-of-plane bending of the moment frame beam to column connection to transfer forces to the tension rod bracing. This indirect load path is not desirable for a building with an Immediate Occupancy structural performance objective. See Figure 3.76. • Steel beams and columns likely do not meet section compactness requirements for highly ductile member.

(a) East Bay without Rod Bracing

(b) West Bay with Rod Bracing

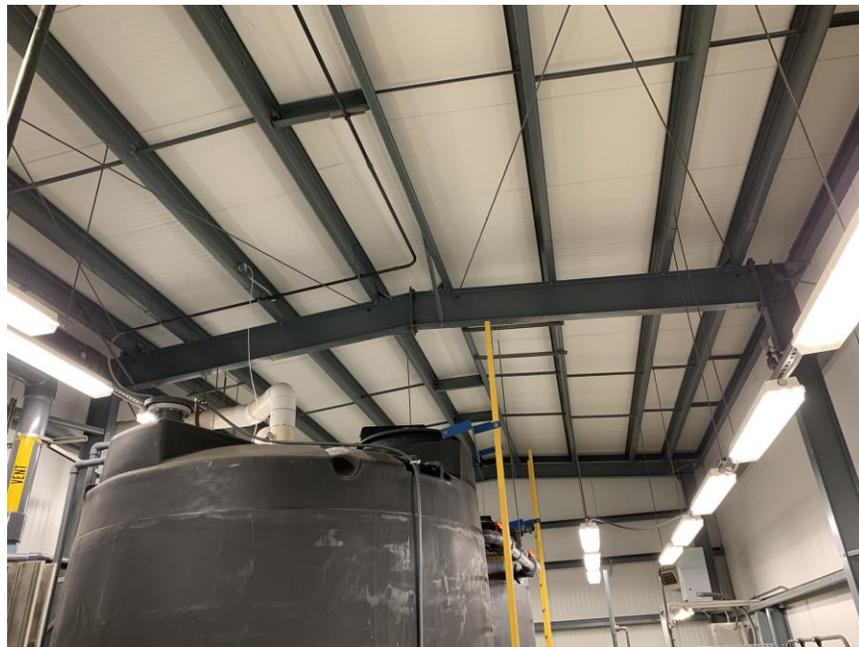
Figure 3.74 – Single Lateral Force Resisting Bay in Frame Line along North-South Direction

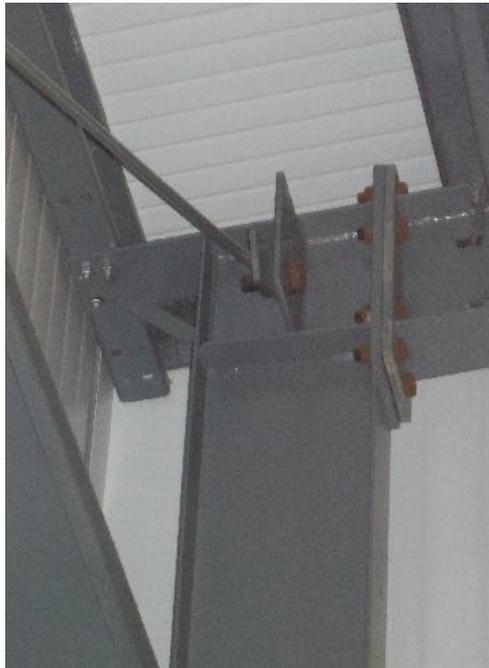
Potential Deficiencies	Description
<p>Structural (cont.)</p>	<ul style="list-style-type: none"> • It is likely that the moment resisting connections do not have adequate capacity to develop the expected strength of the adjoining beam and column members and panel zones may not have adequate capacity to resist expected shear force demands. See Figure 3.77. • Purlin splices may not have adequate capacity to resist cross tie forces. See Figure 3.78. • Grout layer is not provided under column base plates and nuts on anchor rod are not tight. See Figure 3.79.
<p>Nonstructural</p>	<ul style="list-style-type: none"> • Pipes from the exterior salt brine tank into process equipment inside the building do not have adequate flexibility to accommodate the expected relative movement between the tank and building. See Figure 3.80. • Drain pipe from the exterior salt brine tank through the concrete slab does not have adequate flexibility to accommodate potential relative movement between tank and the slab. See Figure 3.81. • PVC Vent Piping is not braced to the structure either inside or outside the building. See Figure 3.82. • Pipes connecting the two sodium hypochlorite tanks do not have adequate flexibility to accommodate potential relative movement between the tanks. See Figure 3.83. • Piping connected to both the Sodium Hypochlorite Generation skid and the building does not have flexibility to accommodate the expected building movement. See Figure 3.84. • Anchorage of chemical feed pumps is potentially not adequate due to small diameter and missing anchors. See Figure 3.85. • Hot water heater is not adequately braced to the structure as it has only one strap restraining it instead of two. See Figure 3.86. • Storage barrel is not restrained. See Figure 3.86. • Water softener components are not restrained. See Figure 3.87. • Instant hot water heater is not adequately restrained (only restrained against movement in one direction). See Figure 3.88. • Control Panel is not adequately braced to the structure as it is attached only to the relatively flexible fiberglass handrail. See Figure 3.89. • Transformer on strut support is not adequately braced to the structure. See Figure 3.90. • Lights on pendant supports are not braced and may potentially swing and cause damage to other components. See Figure 3.91.

Figure 3.77 – View of Moment Frame Connection and Panel Zone

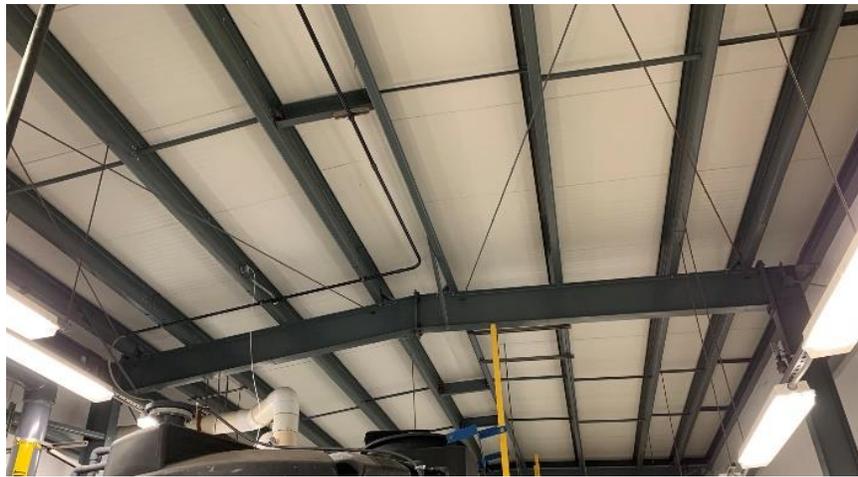
Figure 3.78 – Purlins Between Diaphragm Chords

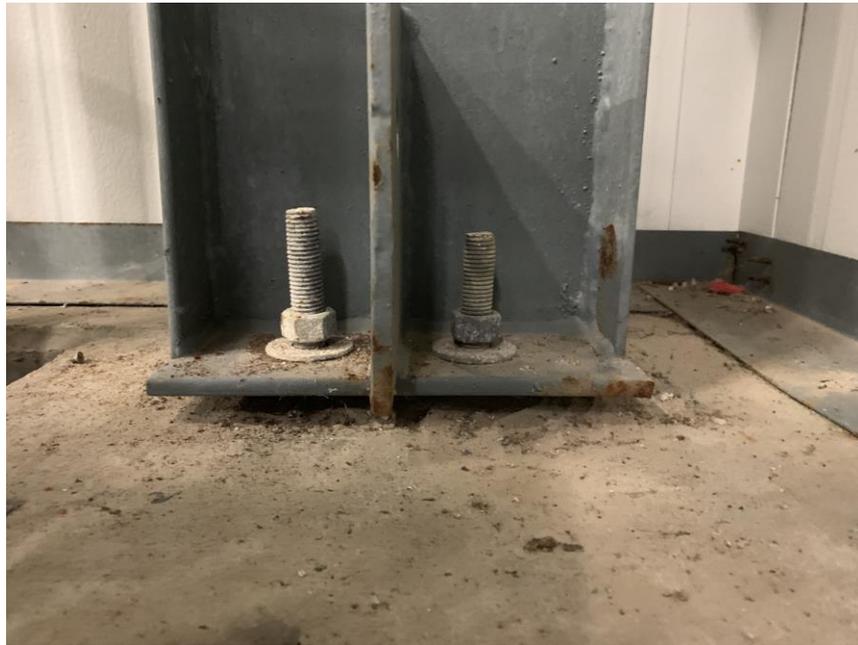
Figure 3.79 – UngROUTed Base Plate and Nuts on Anchor Rods not Tight

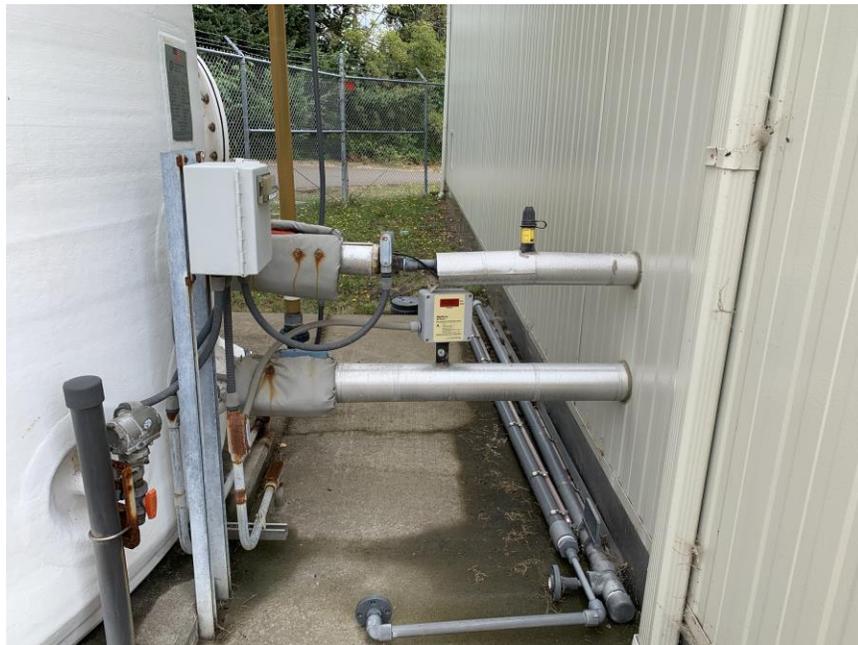
Figure 3.80 – Piping Connecting Salt Brine Tank to Sodium Hypochlorite Generation Building without Adequate Flexibility

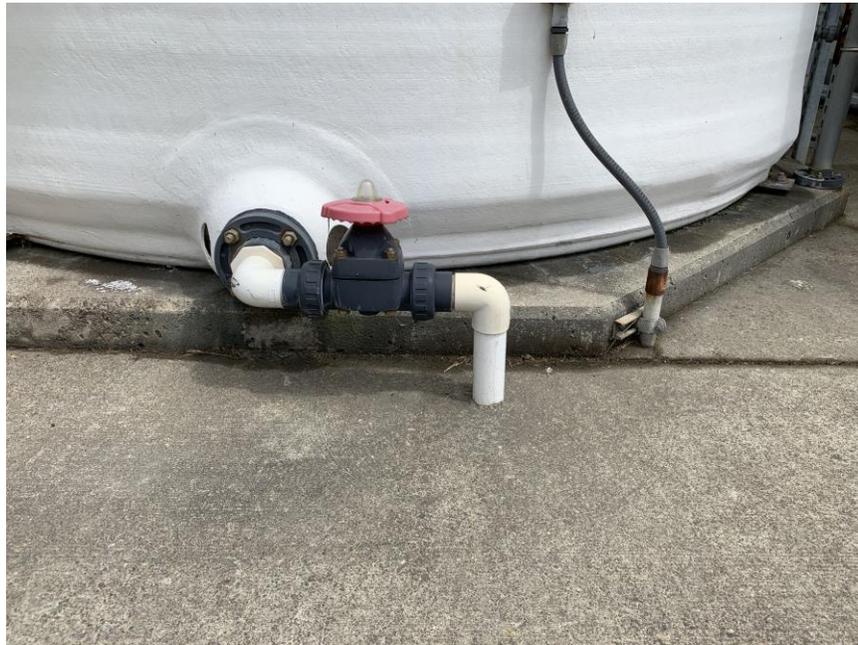
Figure 3.81 – Lack of Flexibility in Salt Brine Tank Drain Pipe

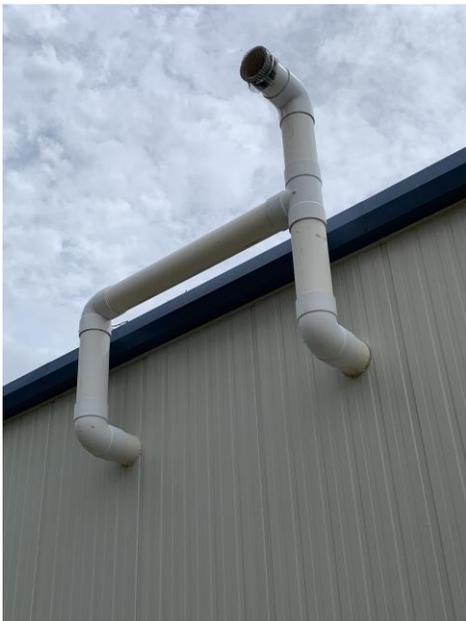
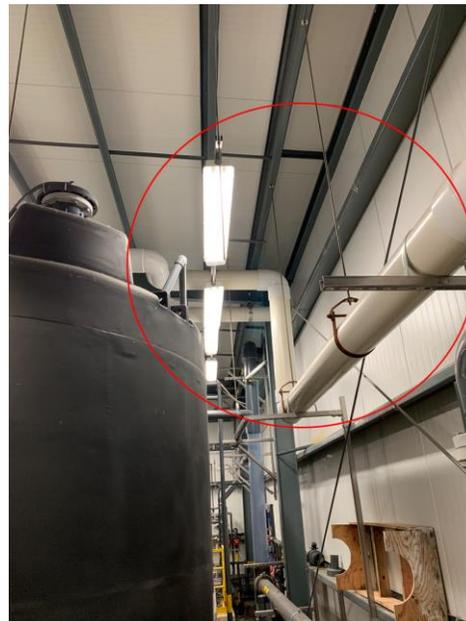
Figure 3.82 – Unbraced PVC Vent Piping

(a) Unbraced Piping Outside the Building

(b) Unbraced Piping Inside the Building

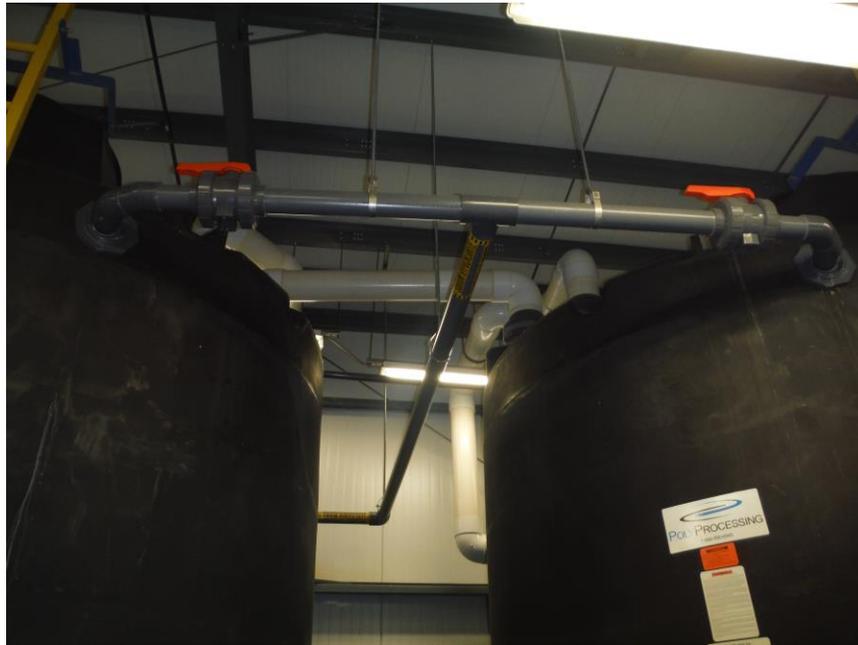
Figure 3.83 – Lack of Flexibility of Piping Connecting Sodium Hypochlorite Tanks

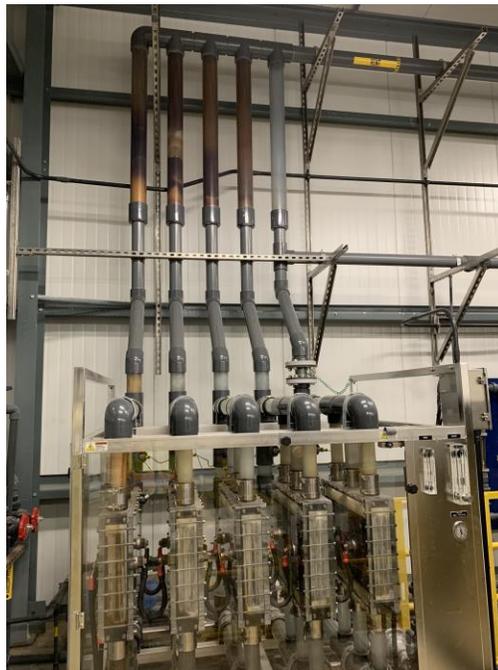
Figure 3.84 – Lack of Flexibility in Piping between Sodium Hypochlorite Generator and Attachment to Building

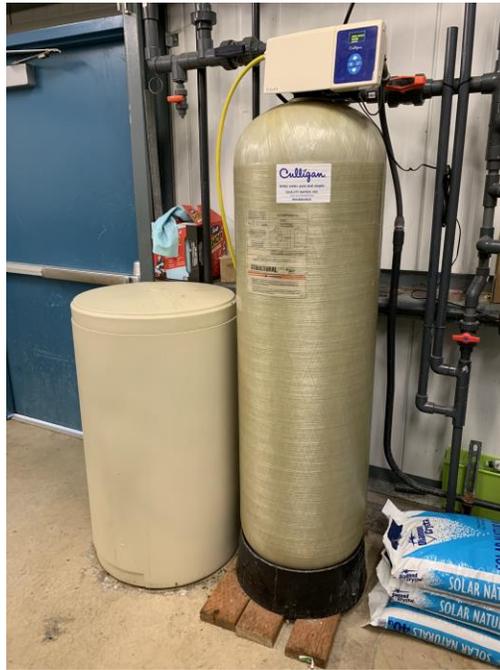
Figure 3.87 – Water Softener Components not Restrained

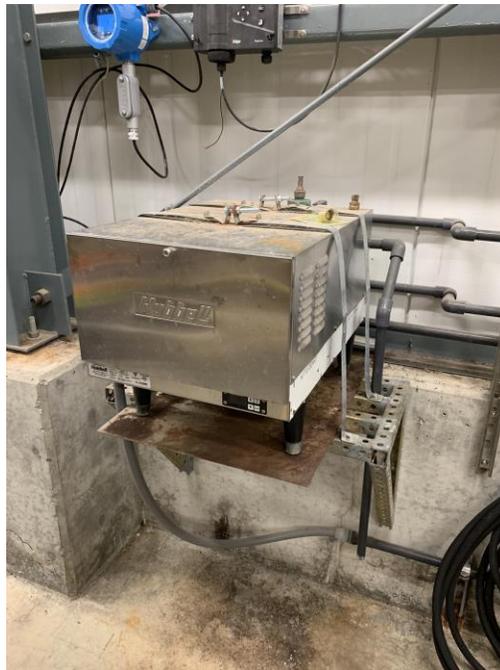
Figure 3.88 – Instant Hot Water Heater not Adequately Restrained
